River Wey Catchment Plan

Wey Landscape Partnership Catchment Plan Consultation

May 2018

On behalf of the Wey Landscape Partnership

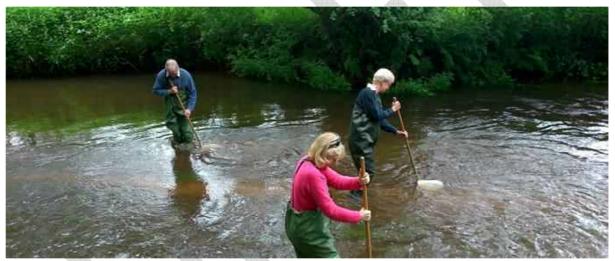
Kick sampling for Riverfly monitoring (photo: Surrey Wildlife Trust).

As well as keeping an eye on what's above the water's surface, SWT also train volunteers to test how clean the water is by looking at the invertebrate community present in the river bed gravels by 'kick sampling', also known as <u>Riverfly monitoring</u>. This method involves disturbing the gravels with your foot and catching the disturbed insect species in a fine meshed net. By looking at the species present it is possible tell if the water is 'clean', due to the different species having different tolerance's to water pollution. This has been a very effective method for pinpointing pollution sources as well as building our knowledge of species distributions across the county. There are now 25 regular monitoring points across both the Rivers Wey and Mole. Monitoring groups include RiverSearch volunteers, angling clubs, colleges and other conservation organisations. For more information contact Glen Skelton (RiverSearch coordinator) glen.skelton@surreywt.org.uk.

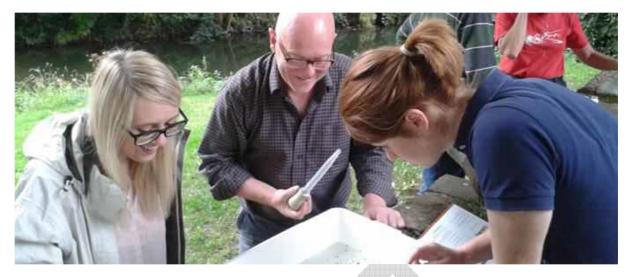
Identifying aquatic invertebrates following kick sampling (photo: Surrey Wildlife Trust).
